CORRODED REINFORCEMENT

NEW CABLE ANCHOR

Granolithic Concrete Floors . . .

RIGID PLASTIC FOAM

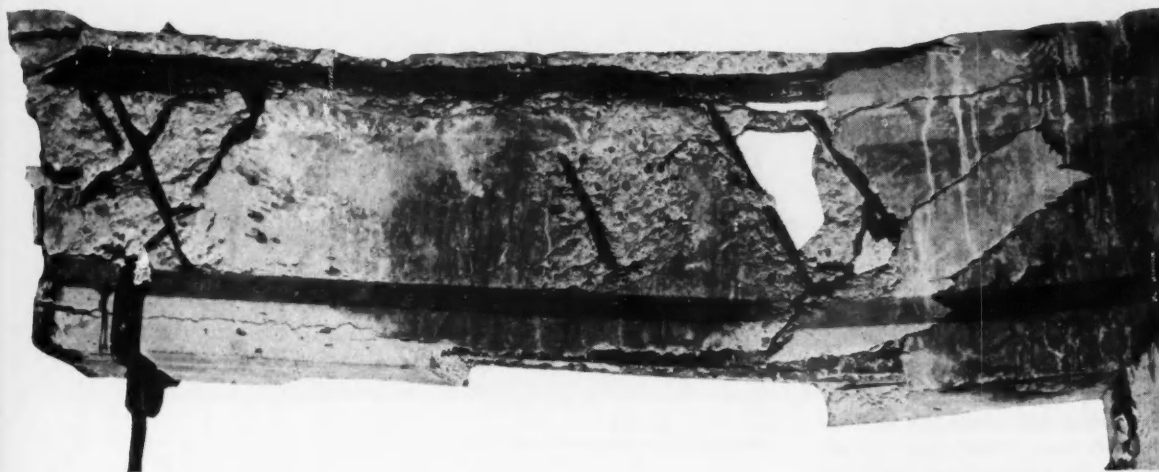
Closeup of concrete beam failure shows severity of deterioration due to corroded reinforcement.

The beams Professor Shermer writes about are precast I-type members installed in 1947 to support the roofs of lumber drying kilns at the Brunswick-Balke-Collendar Company at Muskegon, Michigan. Under exposure to the warm moist atmosphere inside the kilns, and with no protection for the reinforcement except that provided by the concrete of the beams themselves, steel corrosion advanced rapidly enough

to cause structural failure in 1955 under the dead load alone. Corrosion was sufficient to reduce the diameter of some $\frac{7}{8}$ -inch round bars to $\frac{1}{2}$ inch or less.

The concrete itself was of a fair quality. Small specimens cut from the beams tested from 3,000 to 4,000 p.s.i. Functioning as a consultant called in after the failure, Professor Shermer reached the conclusion that the beams were literally burst apart by the corrosion of the reinforcing steel. The expansion of the metal as it oxidized set up disruptive stresses that the concrete could not withstand.

But why the corrosion in the first place? Professor Shermer is convinced that there was not enough concrete over the reinforcing steel to protect it from exposure to air and moisture.

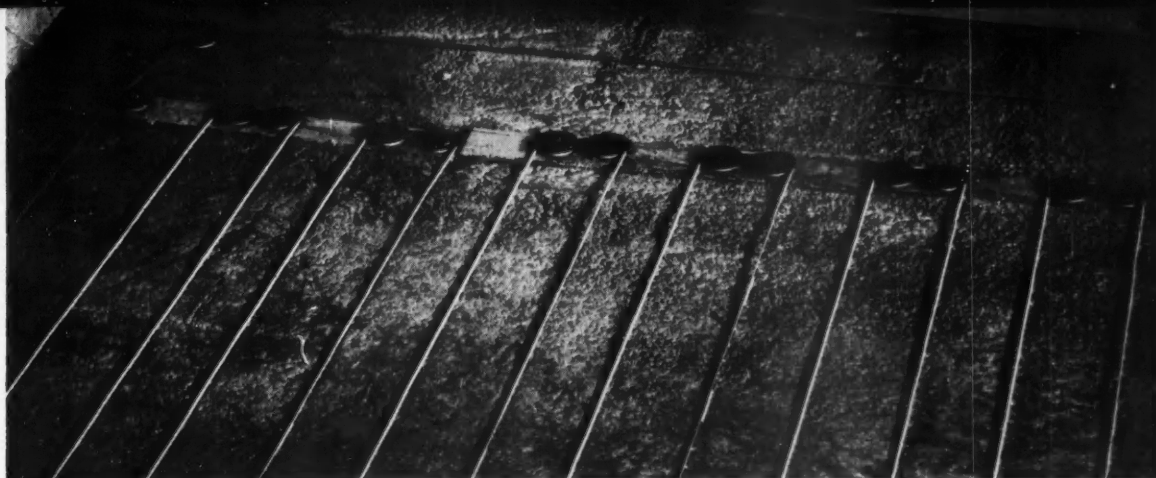
In upper left corner one cable anchor is fastened directly into concrete; others are secured to nailing strip.

to solve these very problems. It consists simply of two circular fiber discs, one of larger diameter than the other, with a hole through the center. One anchor provides for minimum cable spacing of 1 inch, but the use of two anchors for each cable loop will make provision for any desired spacing greater than 1 inch (see sketch).

The anchors are placed by simply nailing them into strips of wood set in the base concrete, or by means of special nails driven directly into the base concrete. The small disc in each anchor is thick enough to keep the cable from being crushed, and its shape permits the cable to wind back and forth without being kinked. The larger disc, which must be on top, holds the cable down firmly to the base and prevents it from slipping off the smaller disc. In the subsequent concrete pouring operations, cables anchored in this fashion are said to remain firmly in place without incurring damage from wheelbarrows or power buggies.

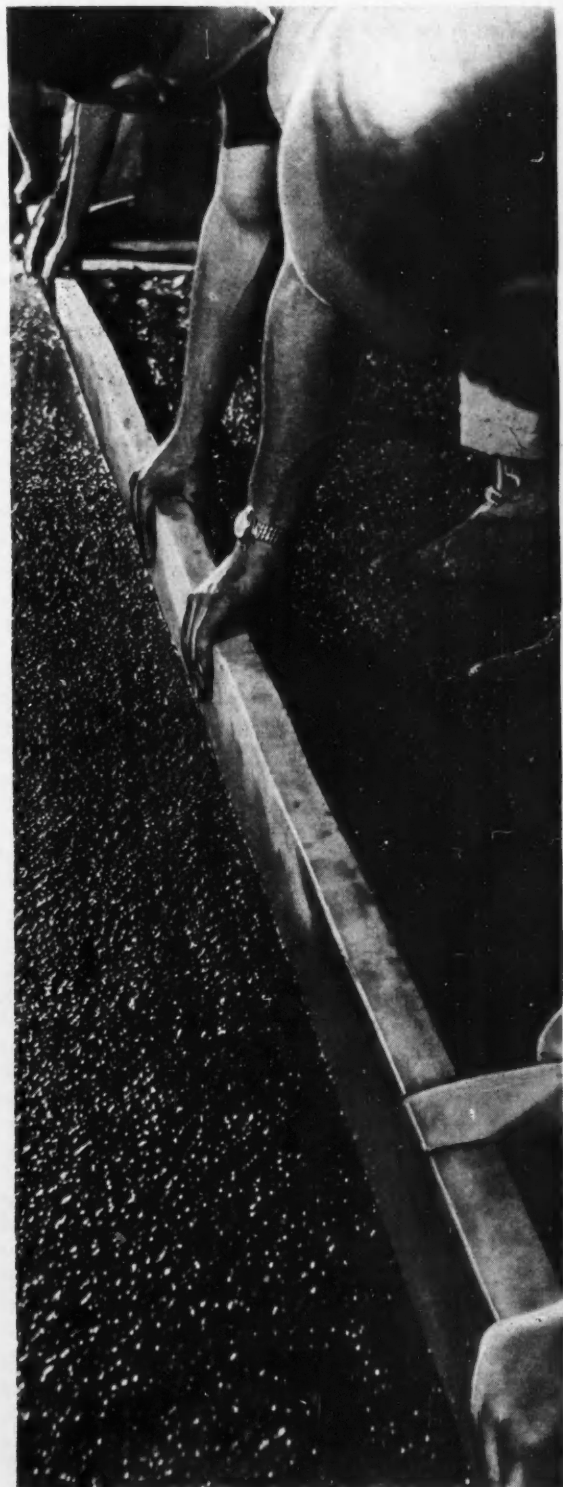
Step One. After preliminary preparations, including wire brushing and wetting the base slab and working in grout coat, the first step in applying an absorption process granolithic concrete floor is to place and screed the concrete mix, which contains just enough water to permit easy workability.

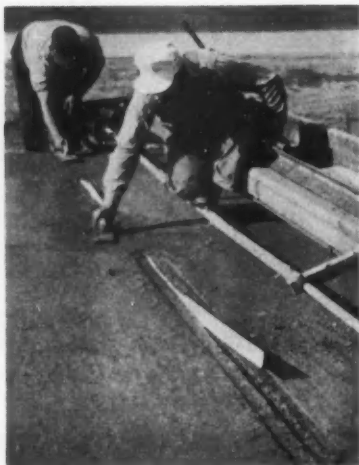
Hand tools are used to remove the plastic filler material after the concrete has set. The joint is then sand-blasted and sealed.

In the highway pavement application mentioned earlier, $\frac{1}{2}$ - by 2-inch strips of the rigid foam are used in place of regular asphalt-impregnated fiber board to form transverse contraction joints. The slab is grooved with a joint bar and the strips of plastic foam are fed in, leveled and straightened manually, and the finishing operations proceed. In addition to forming the groove, the plastic acts as a temporary filler to keep the joints free of debris. It is believed that the natural resilience of the material is responsible for a reduction in spalling at the joints.

After the concrete has set and shouldering operations are completed, the strips are pulled out with hooks, and the joints are blown out with compressed air and sealed in the conventional manner. Some 150 miles of

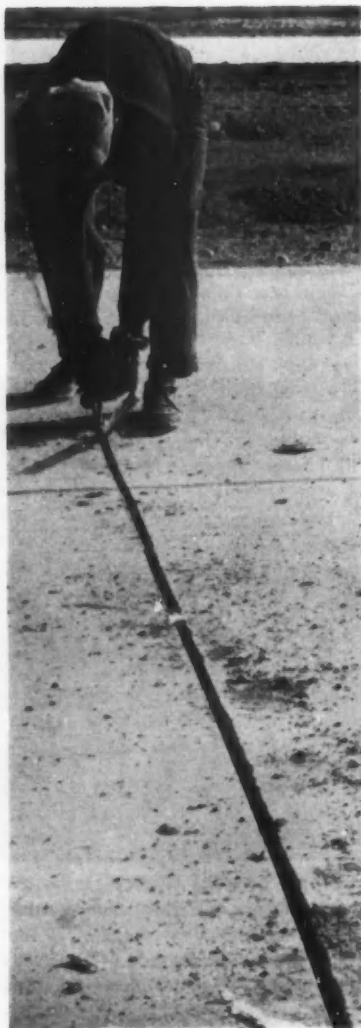
This view, which also appears on the cover, demonstrates a new method for forming transverse contraction joints. It was developed from tests made by the Michigan State Highway Department and is illustrated here by paving operations on U. S. 127 in Michigan. A T-shaped metal bar with a 2½-inch vertical leg is used to form the joint groove in the slab every 99 feet. This operation immediately follows the longitudinal float. After the metal bar has been removed, the groove is prepared for the insertion of strips of plastic foam. As soon as the strips are in place, hand finishing operations restore the concrete surface to a smooth condition in the joint area.

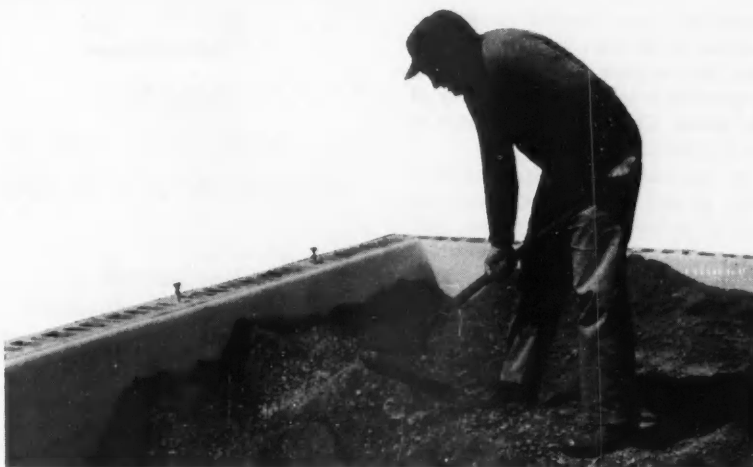
For vertical perimeter insulation, boards of plastic foam may be bonded to the foundation with portland cement mortar. However, the dry boards are generally placed in position as the backfill is accomplished eliminating the need for an adhesive backing.

of 12 to 24 inches, depending on climatic condition and job requirements (see illustration). In horizontal applications the foam boards are simply placed on well-tamped fill and the concrete slab is poured directly over them, while in vertical installations the boards are applied to the inside of the foundation walls before the backfill is shoveled in. Although the pressure of the backfill is sufficient to keep the insulation in place, the boards may be bonded to the foundation with portland cement mortar or cold-setting asphalt adhesive. In all such installations, of course, the main objective is to do away with any solid masonry link between the foundation wall and the slab.

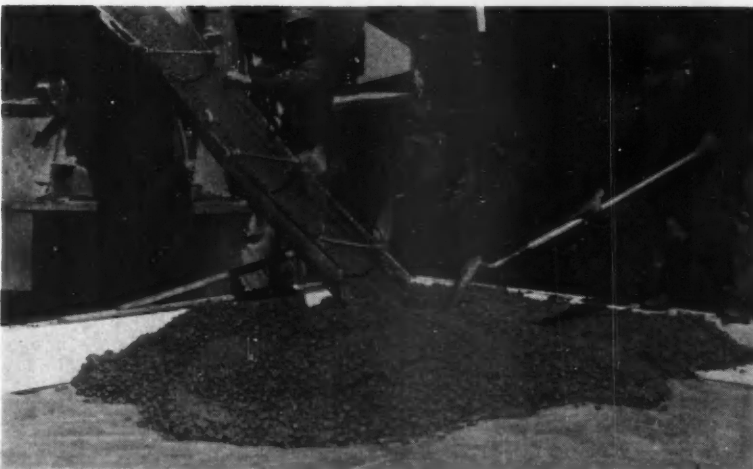
As perimeter insulation, one-inch thick plastic boards may be employed in horizontal or vertical positions. In horizontal installation, as shown here, the material is simply laid around the perimeter of the home. The concrete for the floor is then placed over the vapor barrier and the plastic foam insulation.

For perimeter insulation purposes, 1-inch thick boards are installed either horizontally or vertically to a width
